Investigation of the impact damage due to high-energy objects on the wreckage of flight MH17

Customer
Dutch Safety Board

NLR-CR-2015-155-PT-1 - September 2015

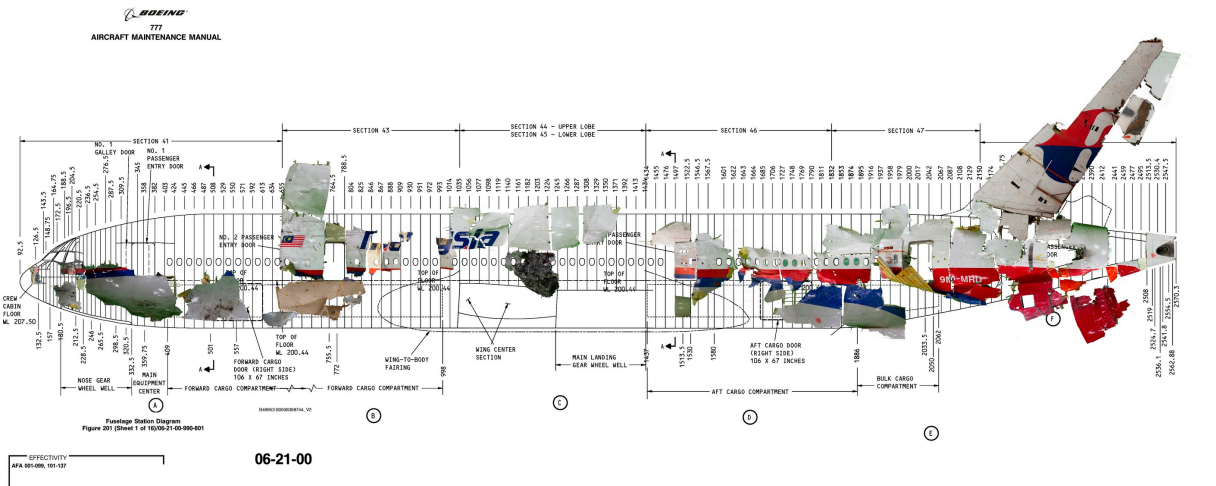
Figure 1: Left-hand side recovered wreckage (Source: DSB)

At the time the investigation commenced, around 25% of the wreckage was available to the Dutch Safety Board at Gilze-Rijen Air Force Base in The Netherlands (Figure 1 and Figure 2). The parts of interest to the investigation were located in one hangar. The remaining parts were located in two separate aircraft shelters. Of each part of the wreckage photographs were taken and these were made available for the investigation. Also a number of 3D laser scans of parts of the wreckage were made and used in this investigation.

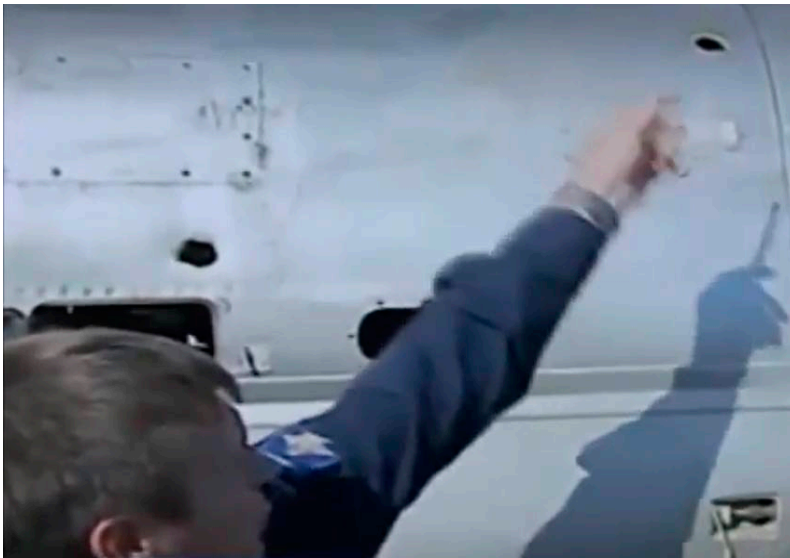
A 23-mm or 30-mm armour-piercing projectile leaves a hole in a thin-walled metal structure, such as that of an airliner, with a more or less round or elliptical shape, with ragged edges, which are bent inwards. The size of the hole is at least equal to, but generally more than the calibre of the projectile. Measurement of the high-energy object damage on a wreckage panel of flight MH17 showed that

the average size of the holes in the panel is around 11 mm. A 23-mm or 30-mm armour piercing projectile is not able to produce an 11 mm hole. An example of the type of impact damage of a 30 mm armour-piercing projectile fired by a GSh-30 cannon can be seen in Figure 38 and Figure 39. A 23-mm or 30-mm high-explosive projectile is designed to penetrate its target and explode after penetration. Hence fragment damage will be generated from the inside, while the blast of the explosion will deform the structure from inside out. If high explosive-incendiary projectiles are used, additional fire damage is to be expected on the inside of the target from the incendiary component of the projectile. The above mentioned types of damage have not been observed on the wreckage of flight MH17.

Figure 38: GSh-30 projectile damage (Source: YouTube)

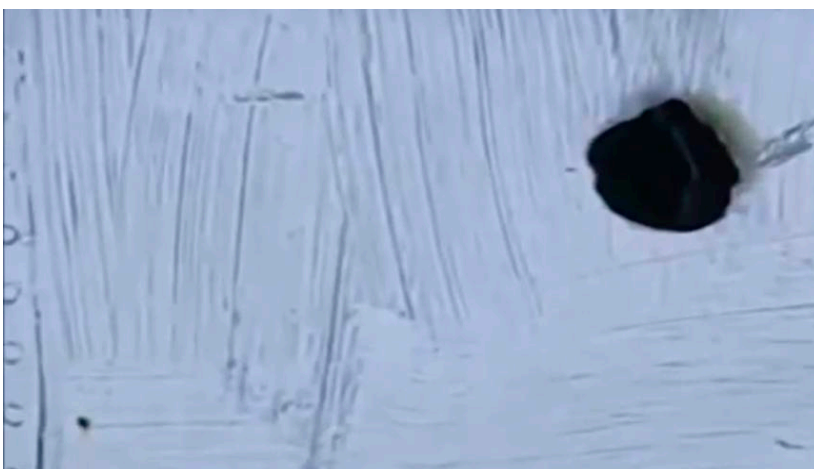
Figure 39: GSh-30 projectile damage detail (Source: YouTube)

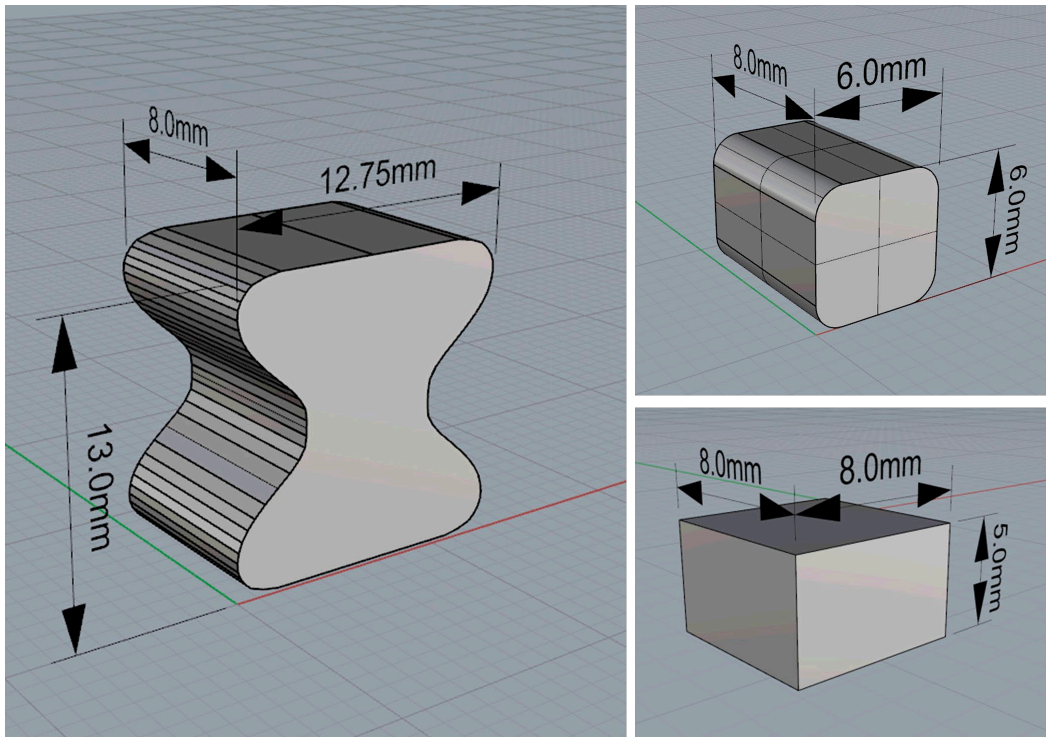
In Section 2.6 the size of the penetration damage was found to range from 6 mm to 14 mm. Figure 51 shows the fragment dimensions of bowtie, filler and square fragments of the 9N314M warhead. Comparison shows that the fragment dimensions of the 9N314M warhead matches with the damage size found on the cockpit area of the wreckage.

Figure 51: Fragment dimensions of bowtie (left), filler (upper right) and square (lower right) (Source: AAIB)

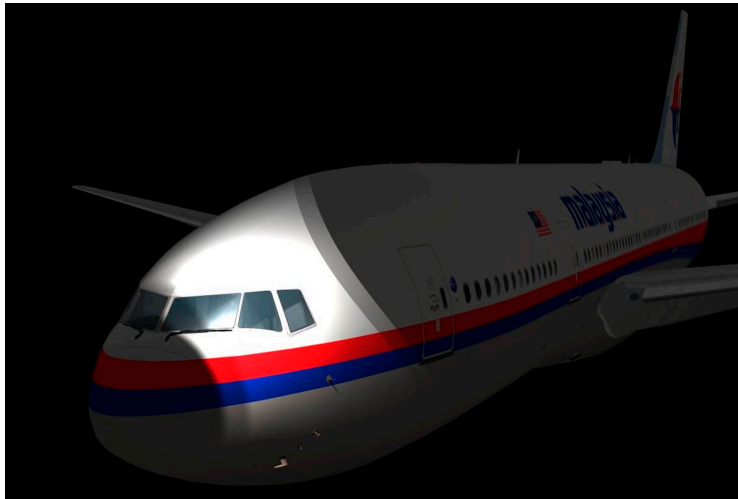
- The boundary and angle of the grazing high-energy object impacts on the roof of the cockpit (Figure 56).
- The boundary and angle of the grazing high-energy object impacts on the left-hand side of the cockpit (Figure 57).
- The boundary of the high-energy object impacts on the captain's (left-hand) front cockpit window and the area of highest damage density around the middle cockpit window on the left-hand side (Figure 58).
- The unaffected area of the cockpit on the right-hand side (Figure 59).

Figure 58: Perspective view of Fragmentation Visualization Model match

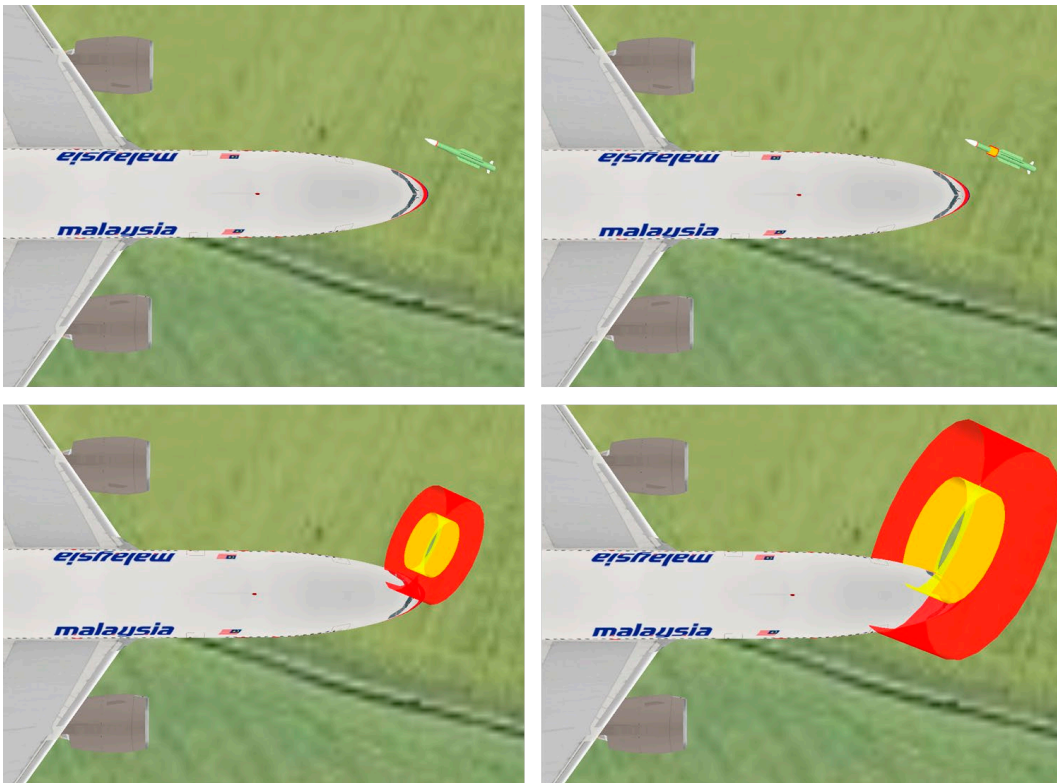
To visualize these results slow-motion movies of the simulation were made. Figure 60 shows several frames of this simulation in a top down view. The red cylinder represents the boundary of the fastest fragments and the yellow cylinder the boundary of the slowest. The fragment spray pattern cloud is a complex shape located in between these two cylinders.

Figure 60: Kinematic Fragment Spray Pattern Simulation showing boundary of fastest (red) and slowest (yellow) fragments, top down view

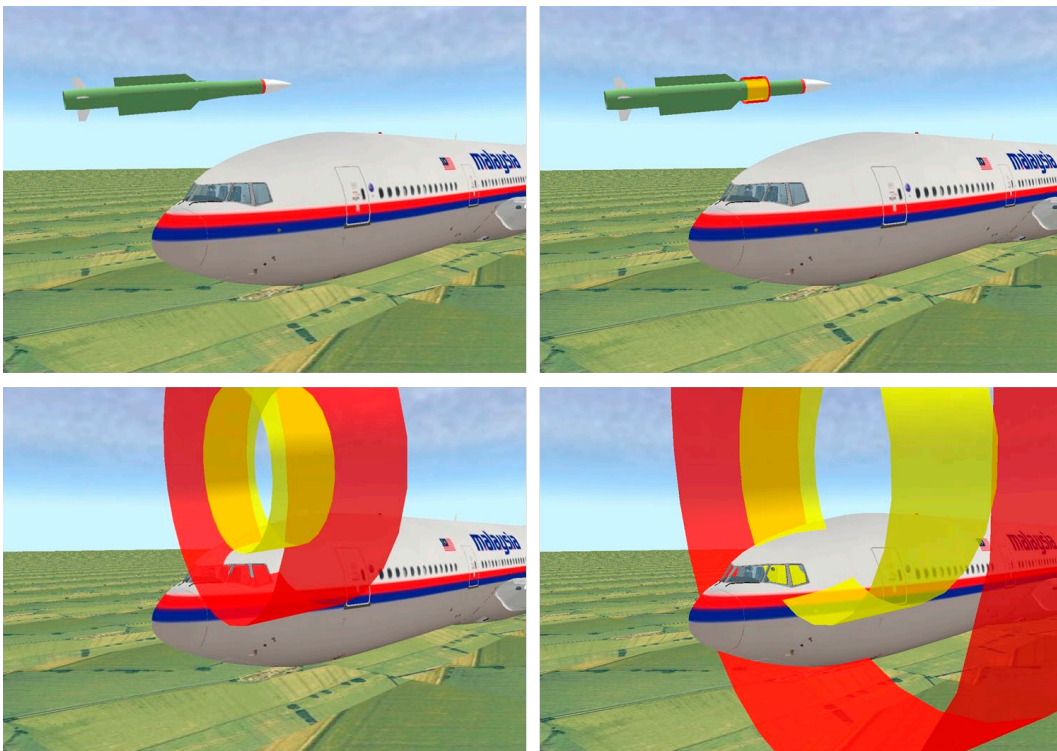
Figure 61 shows several frames of the movie with a perspective view from the left-hand side. The location and the boundaries where the fragments impact the fuselage match with the observed damage as seen in Section 2.9.

Figure 61: Kinematic Fragment Spray Pattern Simulation showing boundary of fastest (red) and slowest (yellow) fragments, perspective view

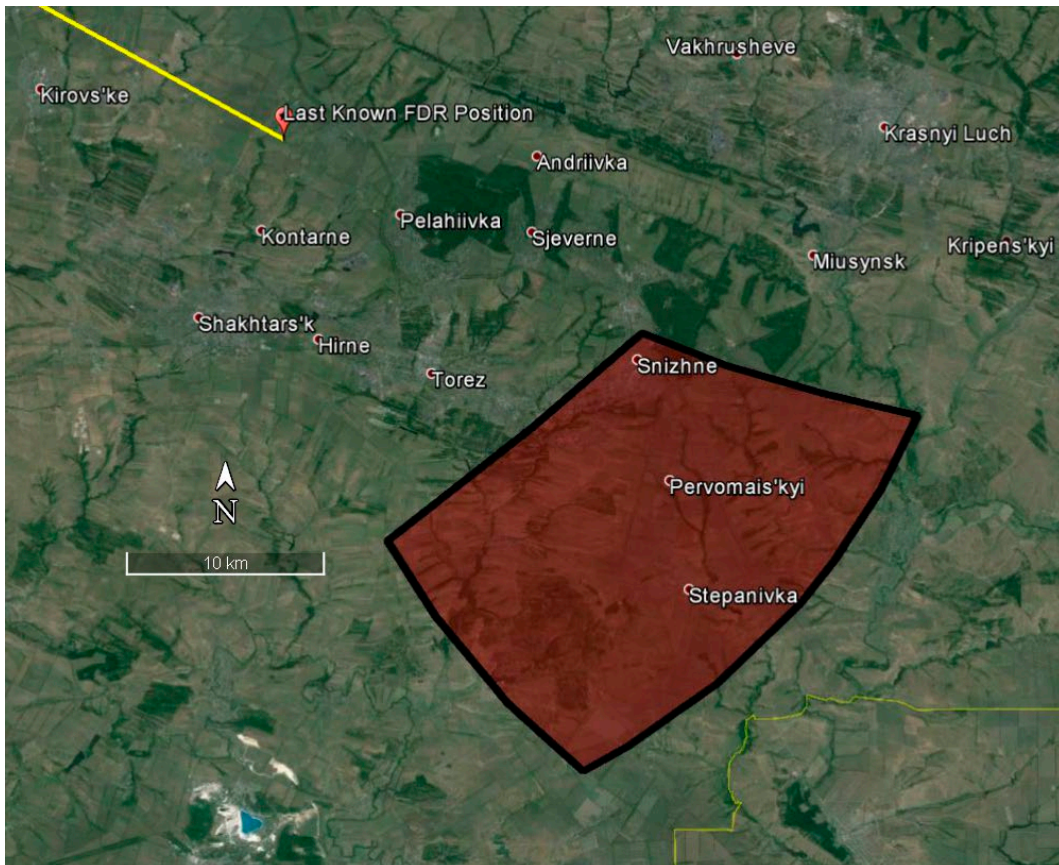
To account for a number of uncertainties in weapon performance and guidance, a range of orientation angles and airspeeds around the best match end conditions was defined. The launch locations for which the simulated end conditions are within this defined range constitute the possible launch area. This means that a missile launched from within this area can result in the damage

pattern observed on the wreckage. This launch area is determined by missile kinematic performance, aerodynamics, seeker limits and is independent of the launching platform. Figure 63 shows this calculated missile launch area on the map together with the flown track and last known FDR position of flight MH17.

Figure 63: Calculated Missile Launch Area (Source: Google earth, CNES/Astrium, US Dept of State Geographer, DigitalGlobe)
